Ο ναός του Αγίου Νικολάου στην Καρύταινα The church of Haghios Nikolaos at Karytaina

ΥΠΟΥΡΓΕΙΟ ΠΟΛΙΤΙΣΜΟΥ ΠΑΙΔΕΙΑΣ ΚΑΙ ΘΡΗΣΚΕΥΜΑΤΩΝ - ΕΦΟΡΕΙΑ ΑΡΧΑΙΟΤΗΤΩΝ ΜΕΣΣΗΝΙΑΣ - ΚΑΛΑΜΑΤΑ 2015
HELLENIC MINISTRY OF CULTURE EDUCATION AND RELIGIOUS AFFAIRS - EPHORATE OF ANTIQUITIES OF MESSINIA - KALAMATA 2015

Ο ναός παρουσίαζε ποικίλα προβλήματα, για την αντιμετώπιση των οποίων εκπονήθηκε ειδική μελέτη από το επιστημονικό προσωπικό της 25ης ΕΒΑ. Το έργο «Αποκατάσταση Ιερού Ναού Αγίου Νικολάου στην Καρύταινα Νομού Αρκαδίας» εντάχθηκε από την ίδια Εφορεία στον άξονα προτεραιότητας «08 – Αειφόρος Ανάπτυξη και Ποιότητα Ζωής Πελοποννήσου» του Ε.Π. «Δυτικής Ελλάδος – Πελοποννήσου – Ιονίων Νήσων 2007-2013», με προϋπολογισμό 300.000,00€ και υλοποιήθηκε με αυτεπιστασία. Από τον Νοέμβριο του 2014 και έως το πέρας του έργου τον Μάιο του 2015 οι εργασίες πραγματοποιήθηκαν από την Εφορεία Αρχαιοτήτων Μεσσηνίας. Στόχος της επέμβασης ήταν η δομική, η αρχιτεκτονική και μορφολογική αποκατάσταση του κτηρίου. Στις εργασίες που πραγματοποιήθηκαν περιλαμβάνονταν:

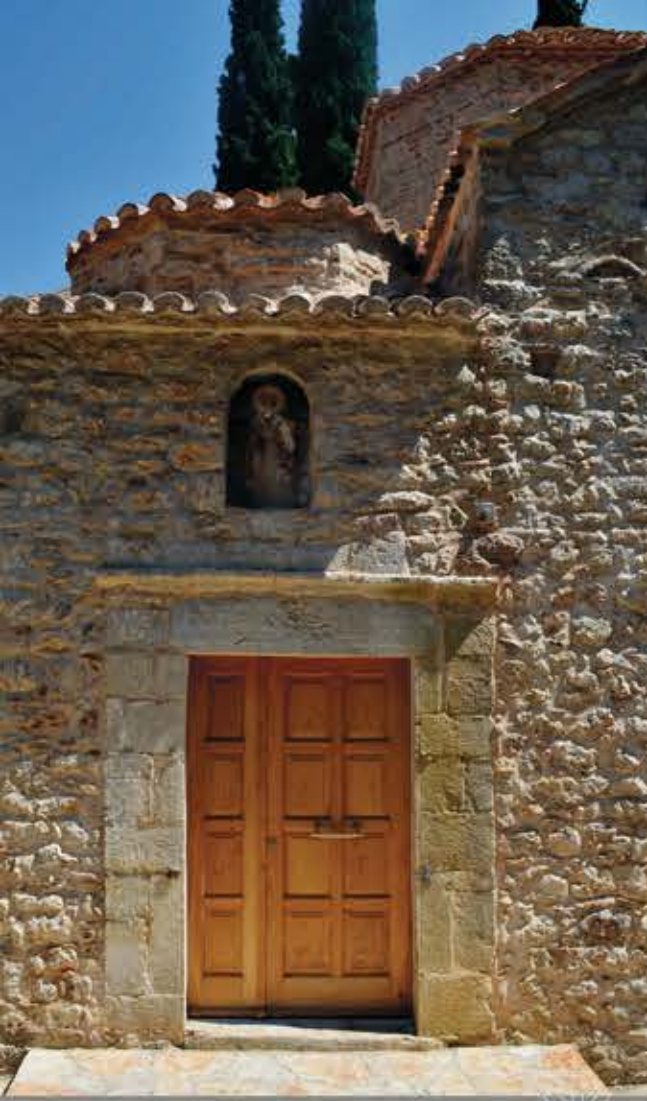
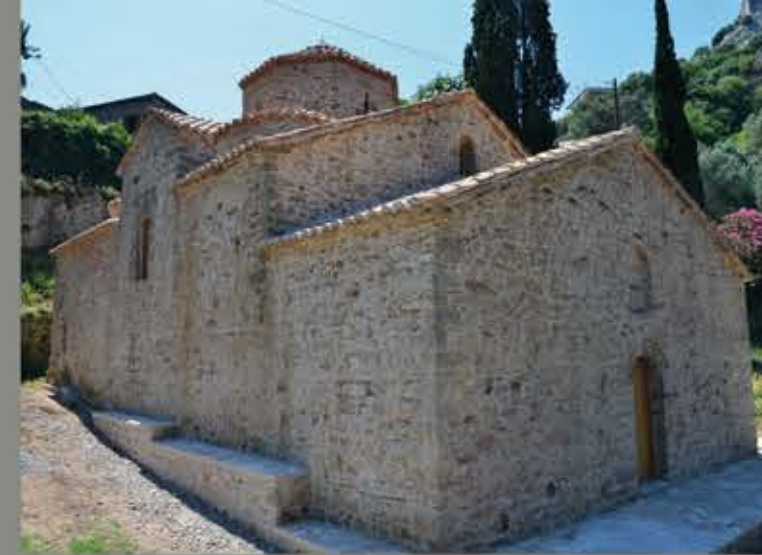
Άποψη του ναού μετά τις αναστηλωτικές εργασίες. Κάτοψη του μνημείου.
View of the church after the restoration works. Ground plan.

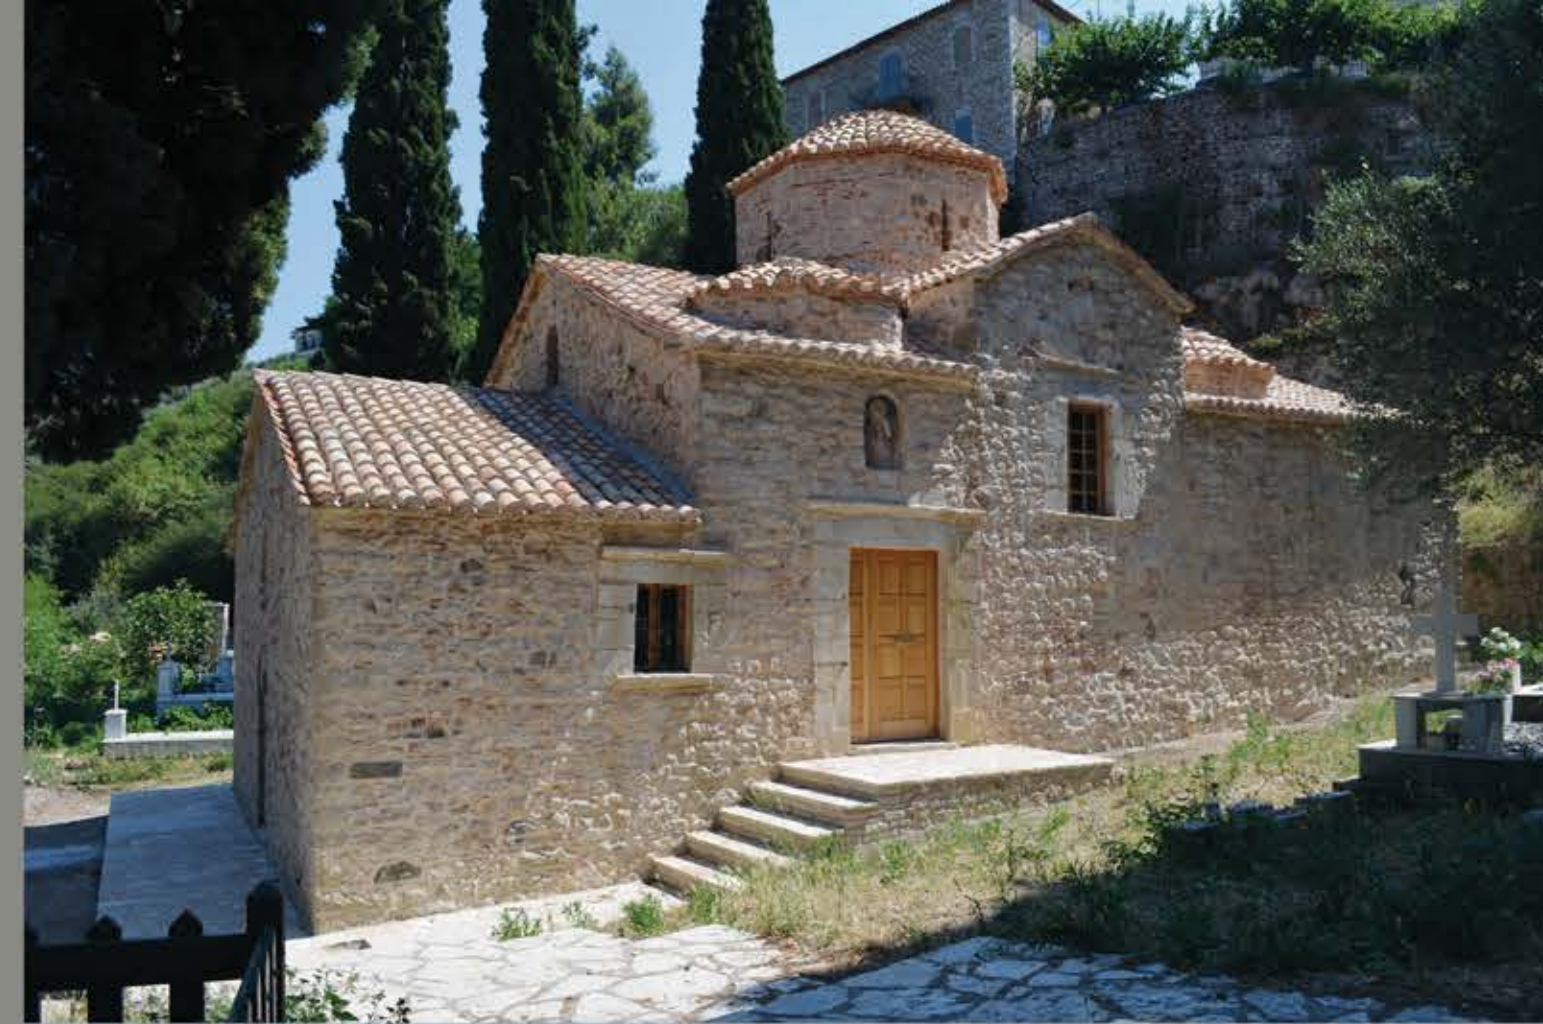
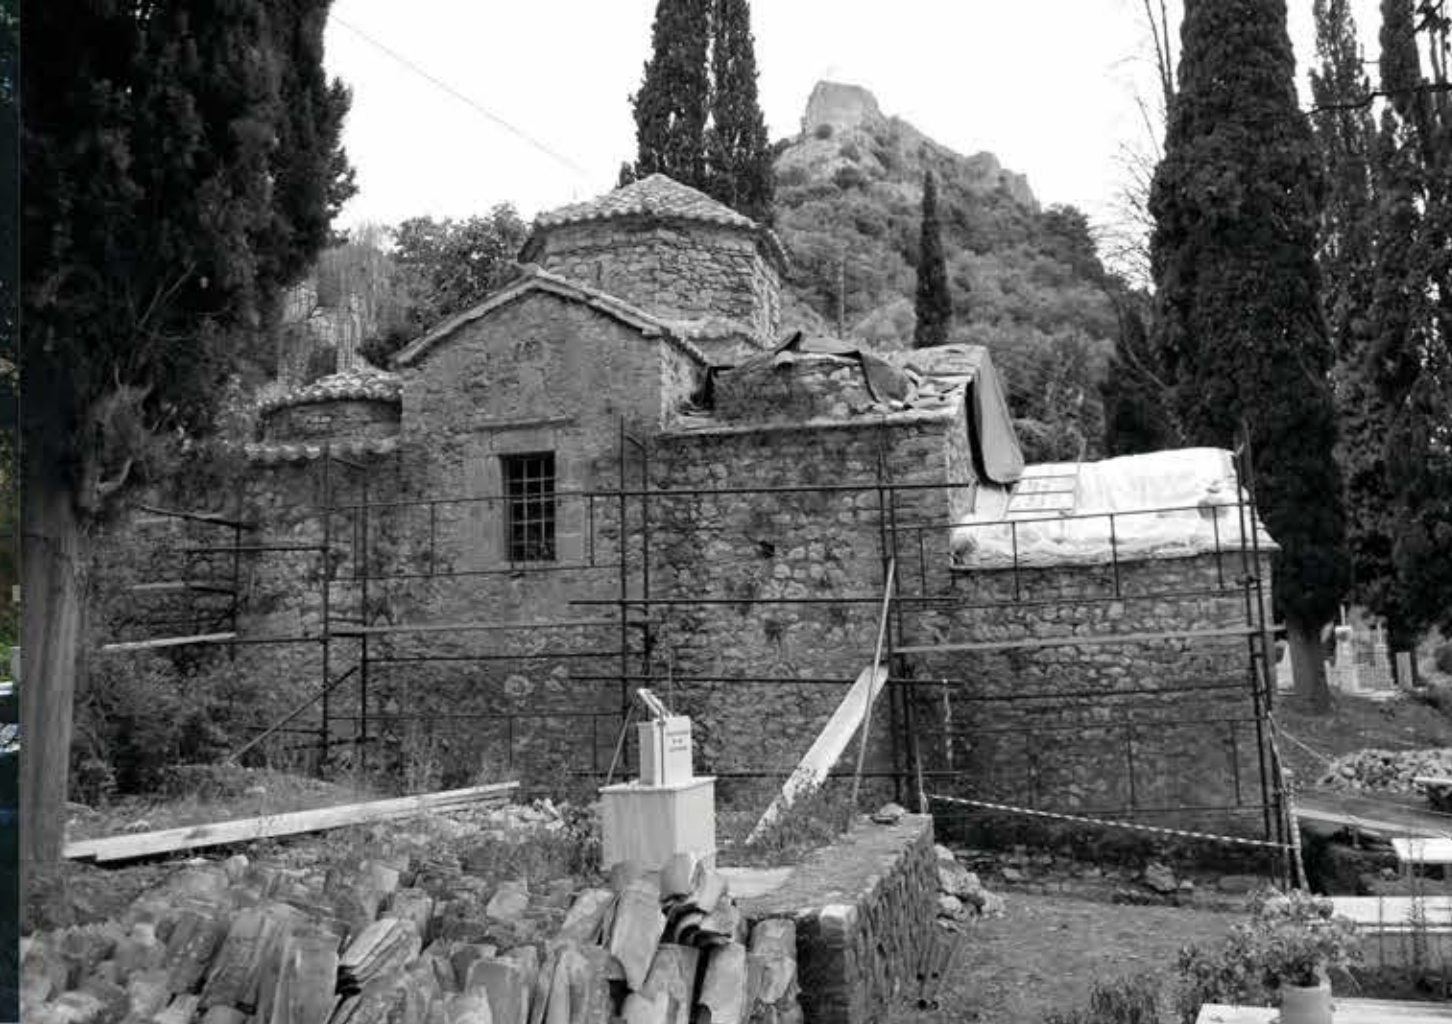
Βόρεια όψη του ναού πριν τις αναστηλωτικές εργασίες.
North facade of the church before the restoration works.

The church suffered serious problems, which demanded urgent action. The scientific staff of the 25th Ephorate of Byzantine Antiquities conducted a specialised study to treat the problems.

- η στερέωση των τοίχων και της θολοδομίας
- η αρμολόγηση των τοίχων
- η τοποθέτηση ελκυστήρων
- η εφαρμογή ενεμάτων
- η κατασκευή νέων κουφωμάτων και
- η πλήρης ανακατασκευή της στέγης με κοίλα κεραμίδια βυζαντινού τύπου.

- Consolidation of the walls and the vaults.
- Painting, joint-filling and grouting.
- Installation of buttresses.
- Installation of new wooden door frames.
- Retiling of the roof with Byzantine type tiles.

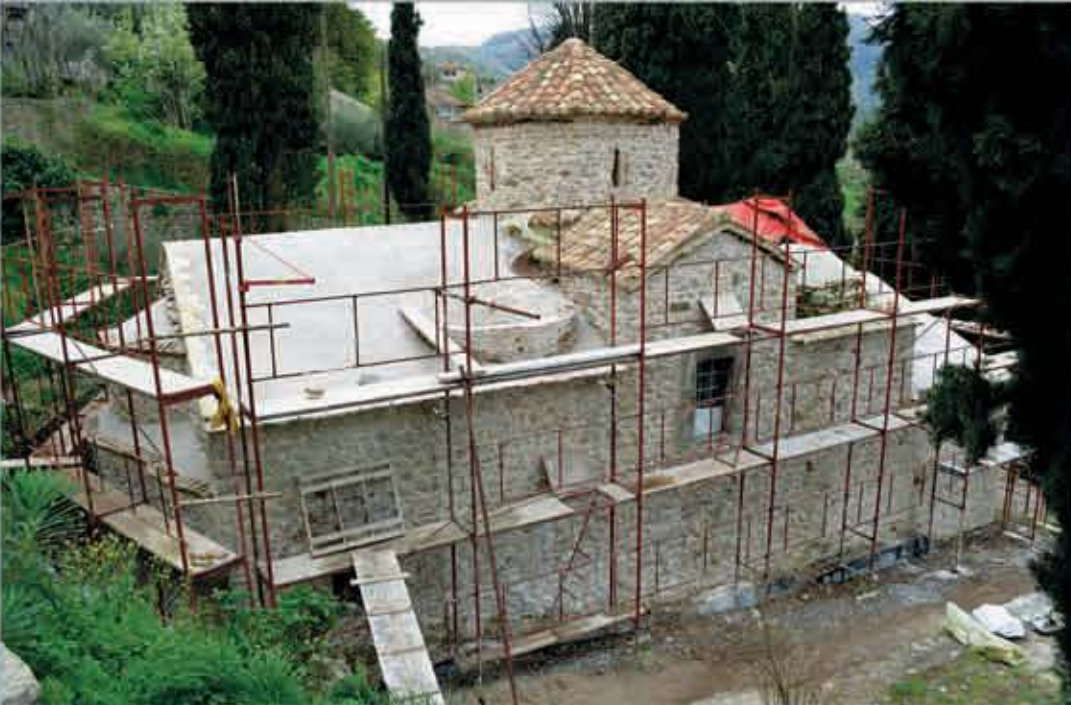
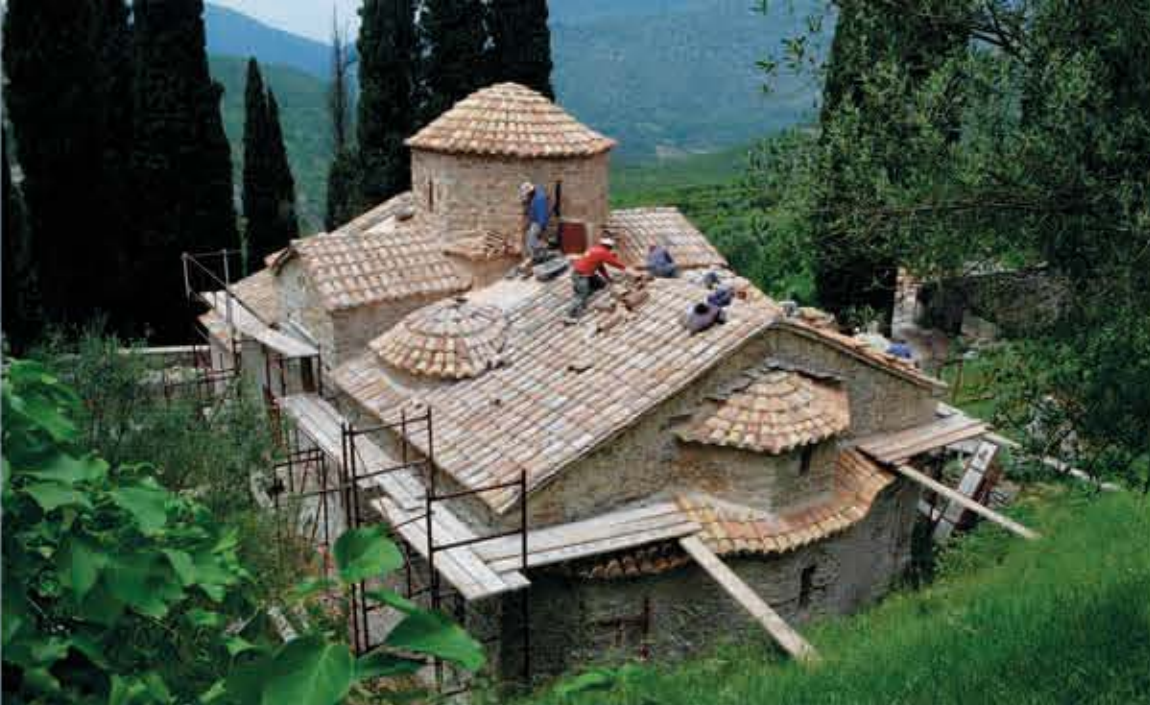
Άποψη του μνημείου κατά τη διάρκεια και μετά την ολοκλήρωση των εργασιών αποκατάστασης
The church during and after the restoration works.

Landscaping works were also carried out and included the rebuilding of a retaining wall on the west side of the church, in order to enhance the monument.
